*Unlocking
the potential
of brown
field sites*

Clean Air Blanket Case Study – Retail Park, Somerset

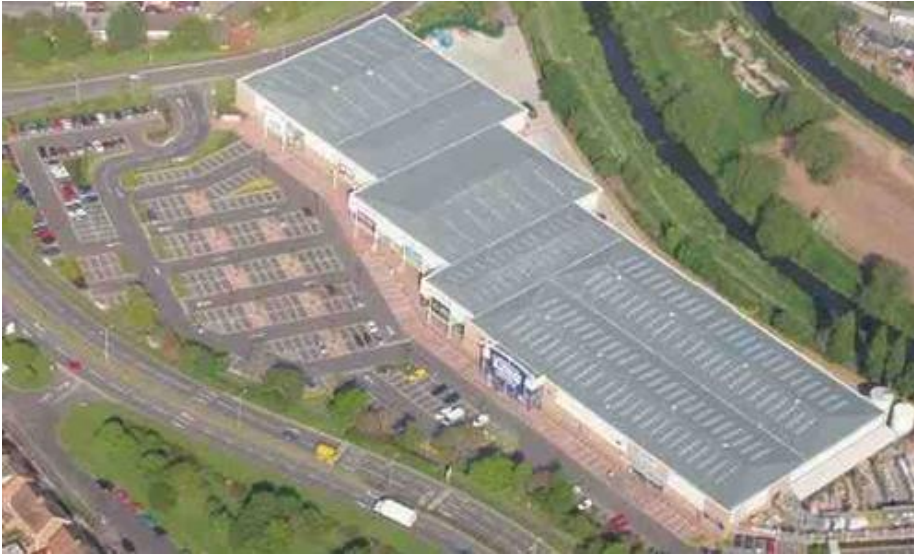
Prestige Air retro-fit the Clean Air Blanket system of gas protection to remediate existing insufficient gas protection systems. Action was required due to breaches in the gas membrane in conjunction with the passive venting system allowing gas accumulation below the building.

At this retail park in Somerset the carbon dioxide levels within the building were triggering the alarms and subsequent investigations which also found levels of methane gas ingress concluded that ground subsidence may have compromised both the passive ventilation system and the gas membrane.

Subsequent investigations using a tracer gas injected into the passive vents revealed numerous ingress points within the structure and the retrospective installation of three positive pressurisation units restored the correct level of gas protection.
